# Air Conditioning Modifications for the GMC RTSII Series 01 Coach (Model TH-8201)

Prepared by:  
Transportation Systems Center  
Urban Systems Division

October 1982  
Final Report

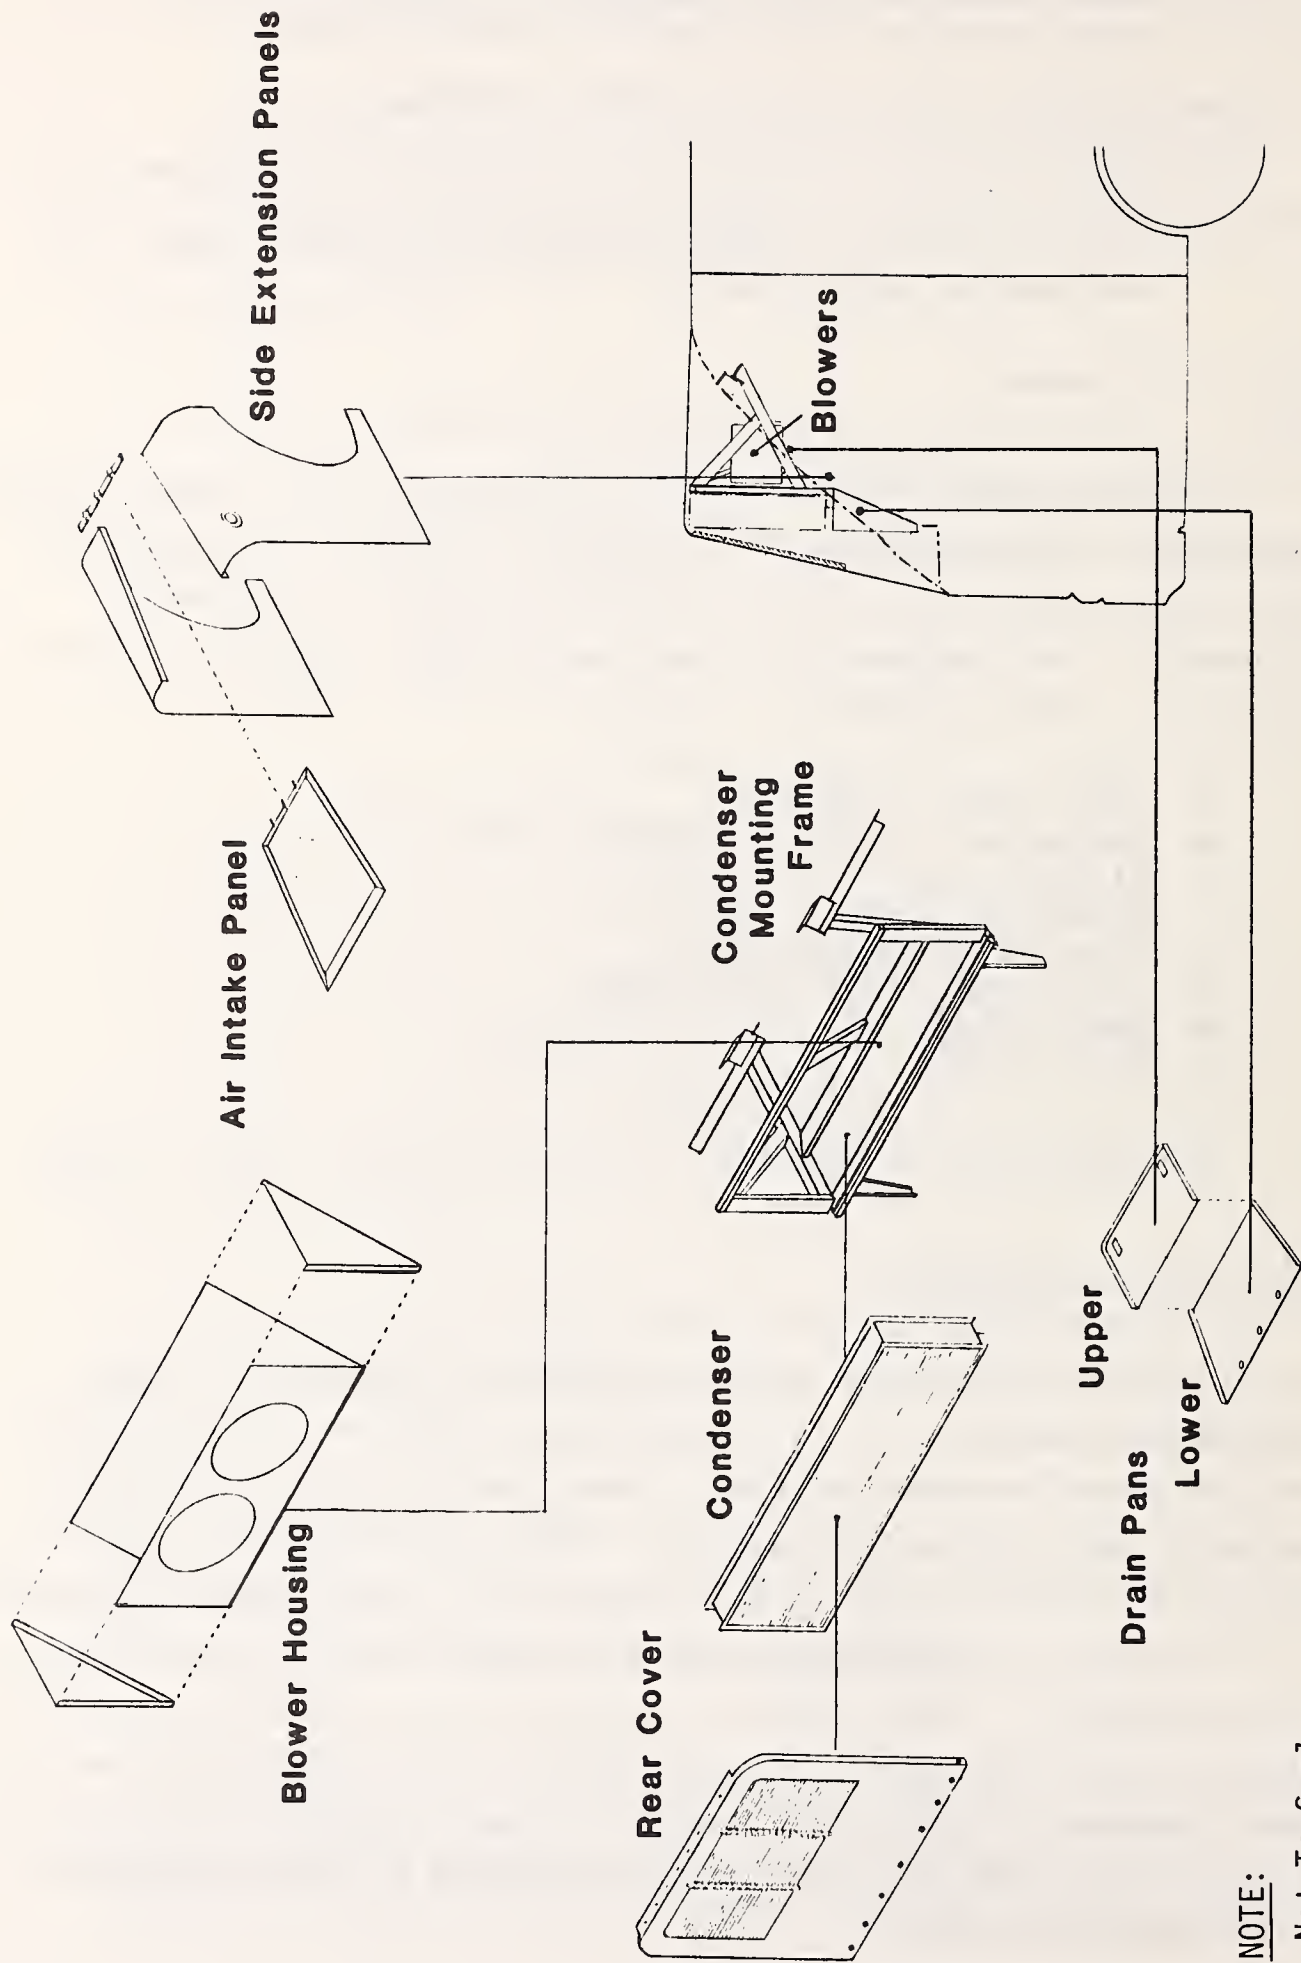
FIGURE 3  
Assembly of Condenser Relocation Components

The principal alteration to the RTS II air conditioning system was the mounting of a smaller refrigerant condenser near the coach roof at the rear of the bus, as shown in Figure 3. The components required for the condenser relocation are the following:

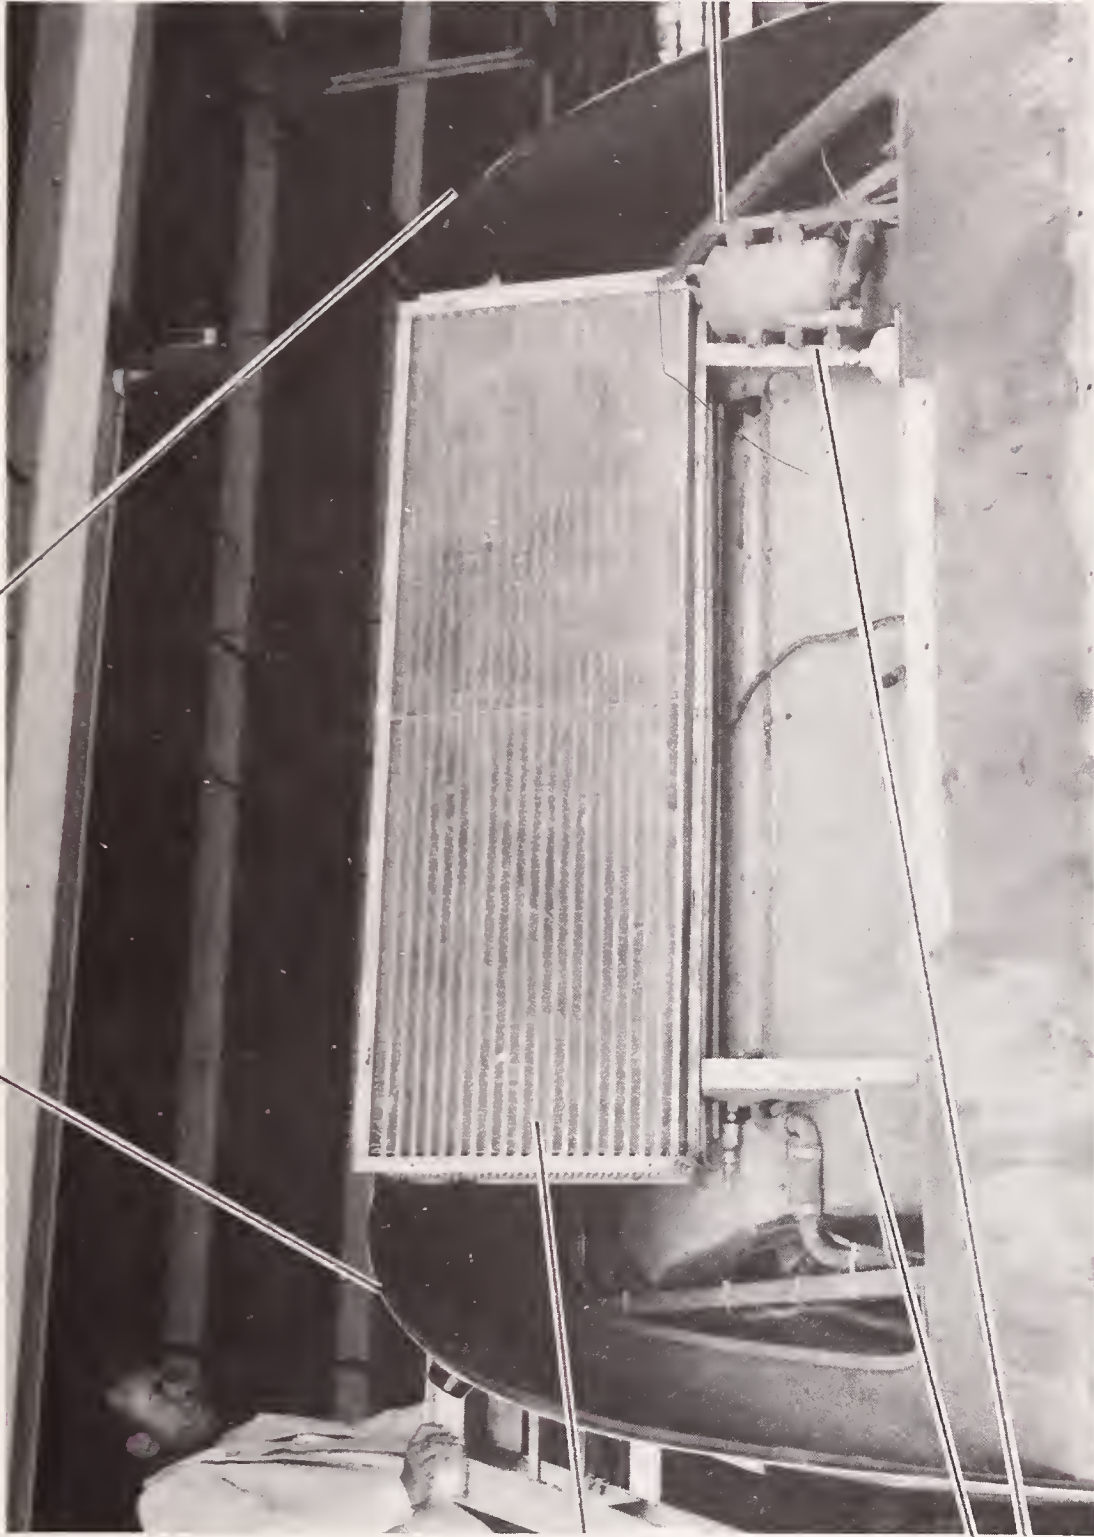
**FIGURE 4**

Because the shape of the original condenser on the Series 01 coaches was not suitable, a smaller, 62-inch wide, standard coil assembly from a "New Look" coach was used to replace the original condenser. This condenser is shown in Figure 4 as installed at the rear of bus #205. The condenser is originally manufactured with a light-weight frame around its perimeter. This frame is used for attachment purposes in the New Look bus and it is retained on the condenser for the same purpose in this application. The condenser is bolted to a mounting frame designed and fabricated by San Antonio VIA Metropolitan Transit.

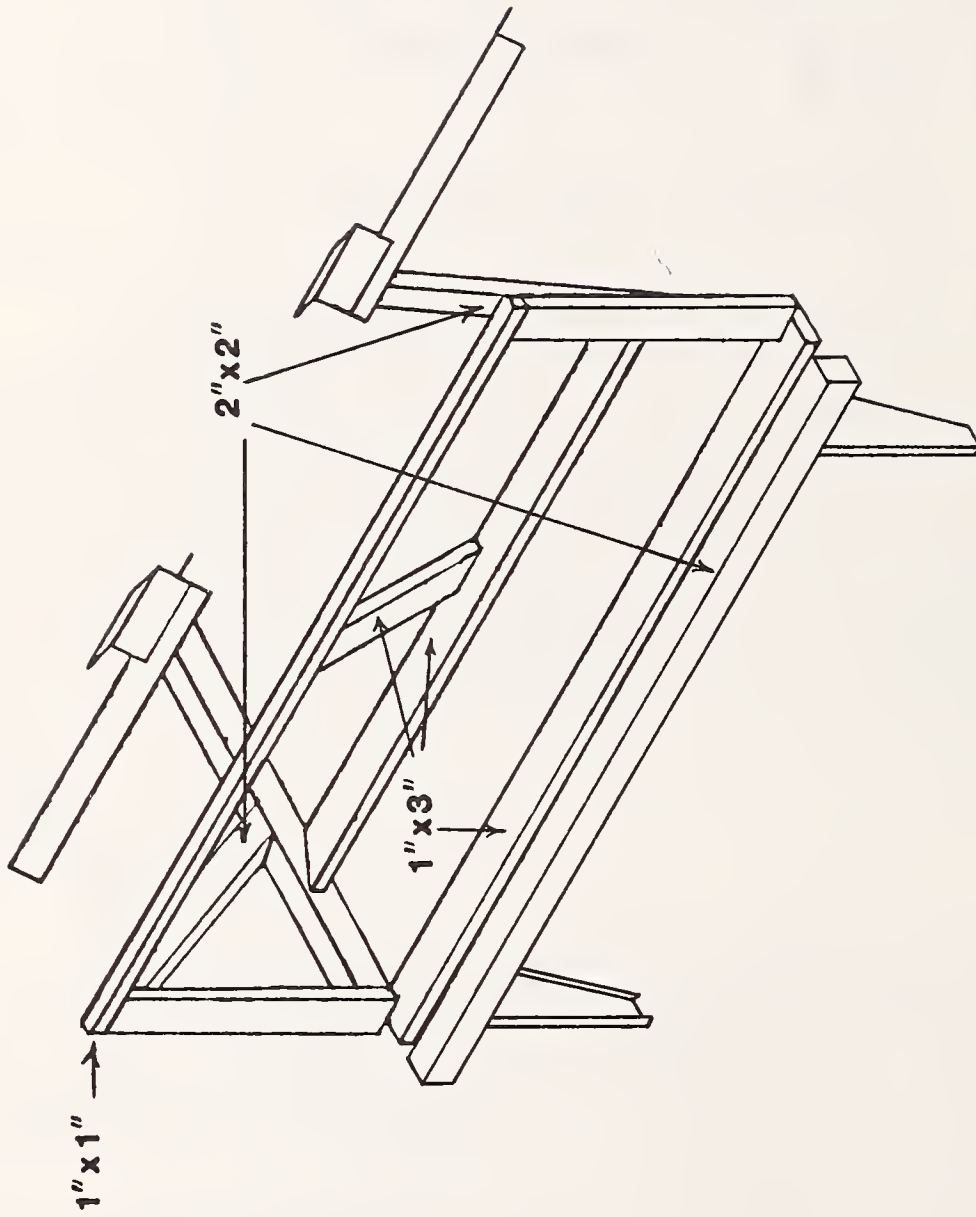
FIGURE 6  
Condenser Mounting Frame

The mounting frame is attached to the bus in three locations: the mounting plates to which the two rear hatch hinges were originally bolted, existing holes in the diagonal frame member in both upper corners of the bus, and the evaporator housing near the original location of the Honeywell control box. The mounted condenser and mounting frame are illustrated in Figure 5. The two upper attachment locations provide most of the support for the assembly; the lower attachment provides lateral fix points. An isometric view of the mounting frame is shown in Figure 6.

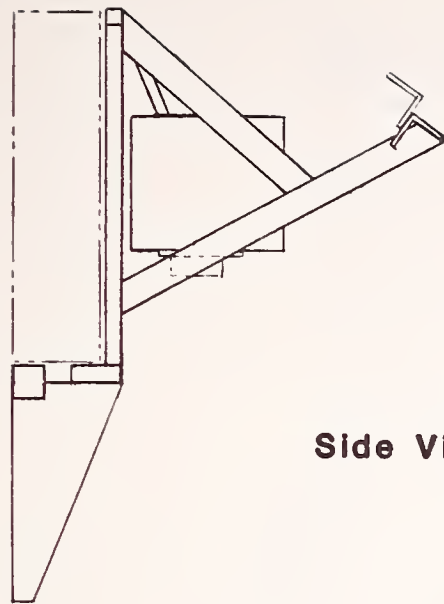
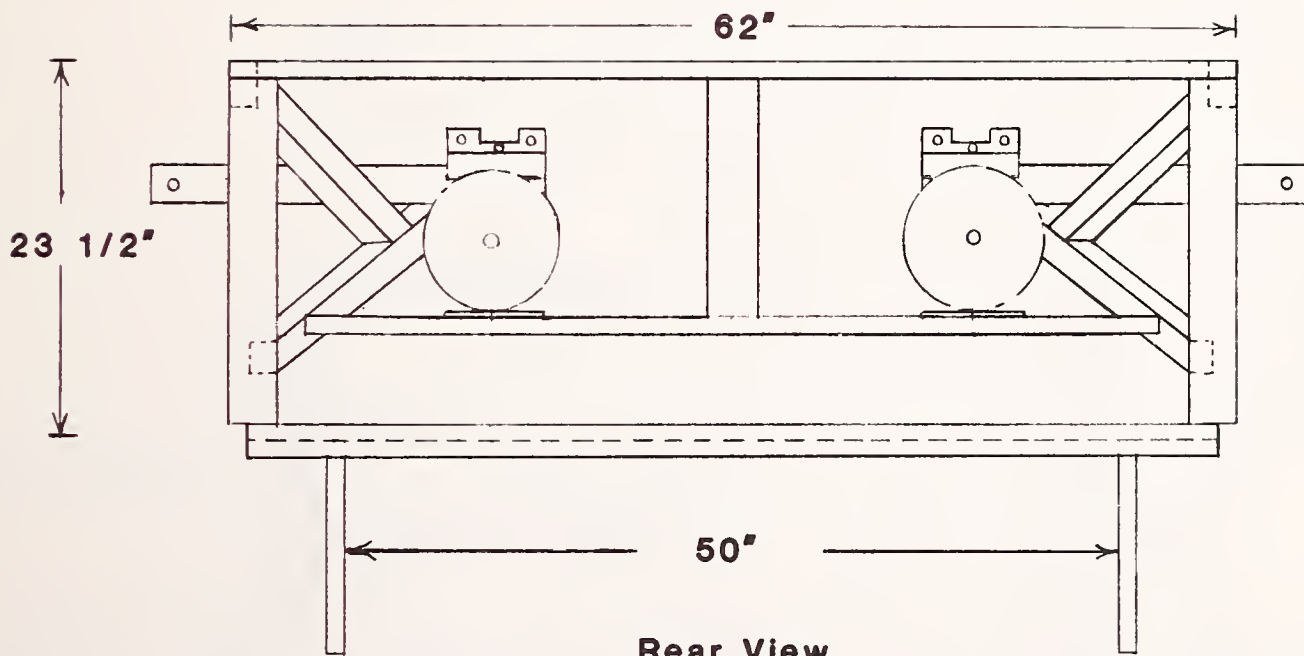
FIGURE 7

The condenser blower motors are cradled on a cross member in the mounting frame. The assembly of the mounting frame and blower motors is shown in Figures 7 and 8. The blowers consist of two GE motors with cast aluminum fans of four blades each. The motors are each less than one-third horsepower and operate directly from the main power supply. The addition of a circuit breaker is the only modification to the electrical system.

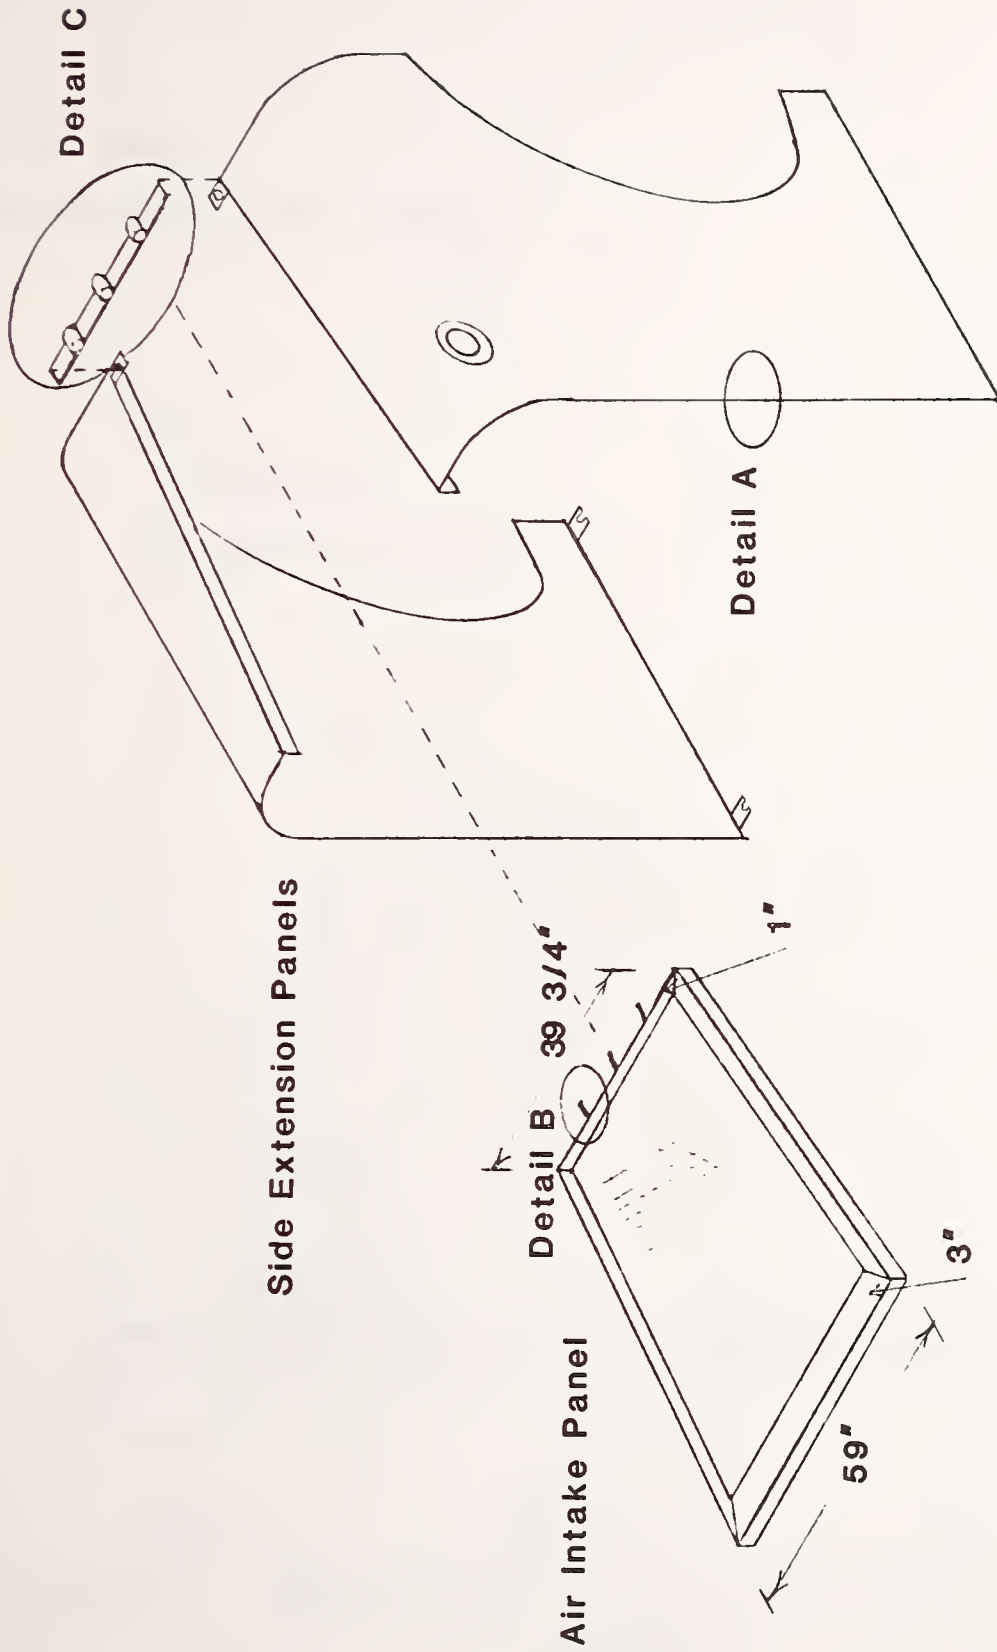
FIGURE 10  
Side Panels and Air Intake Assembly

The air intake cover for the top of the extension is expanded metal grating held in a light frame with three pins attached to its front edge. These pins slide into a clamp which is directly mounted to the bus at the leading edge of the extension. These items are shown in Figures 10 and 11.

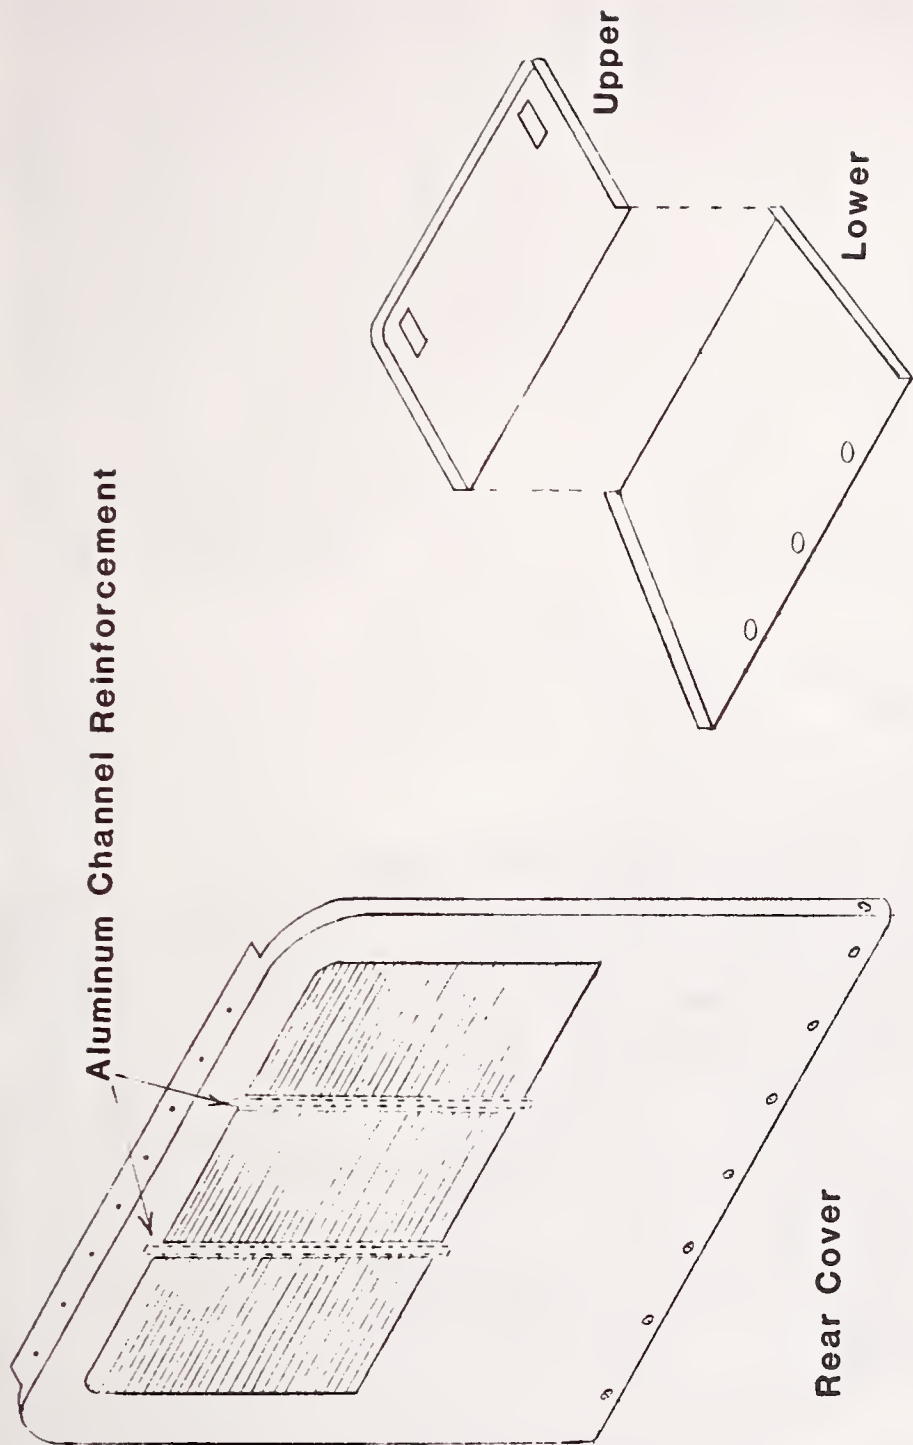
FIGURE 12

The rear cover is molded ABS plastic and is illustrated in Figure 12. The rear cover is given rigidity by its fit in the flange of the sheet-metal side extension panels. Additional rigidity is provided by the attachment of 3/4" aluminum channel strips to the inner face using pop rivets. The cover is fastened with half-inch quarter-turn fasteners, as illustrated in Figure 13.

The drain pans are also molded ABS plastic and are illustrated in Figure 12. The upper pan contains two openings through which the main condenser mounting frame diagonals pass. The drain pan contains a slit from each opening to the nearest side as a provision for mounting the pan on the assembled condenser mounting frame. Following assembly,

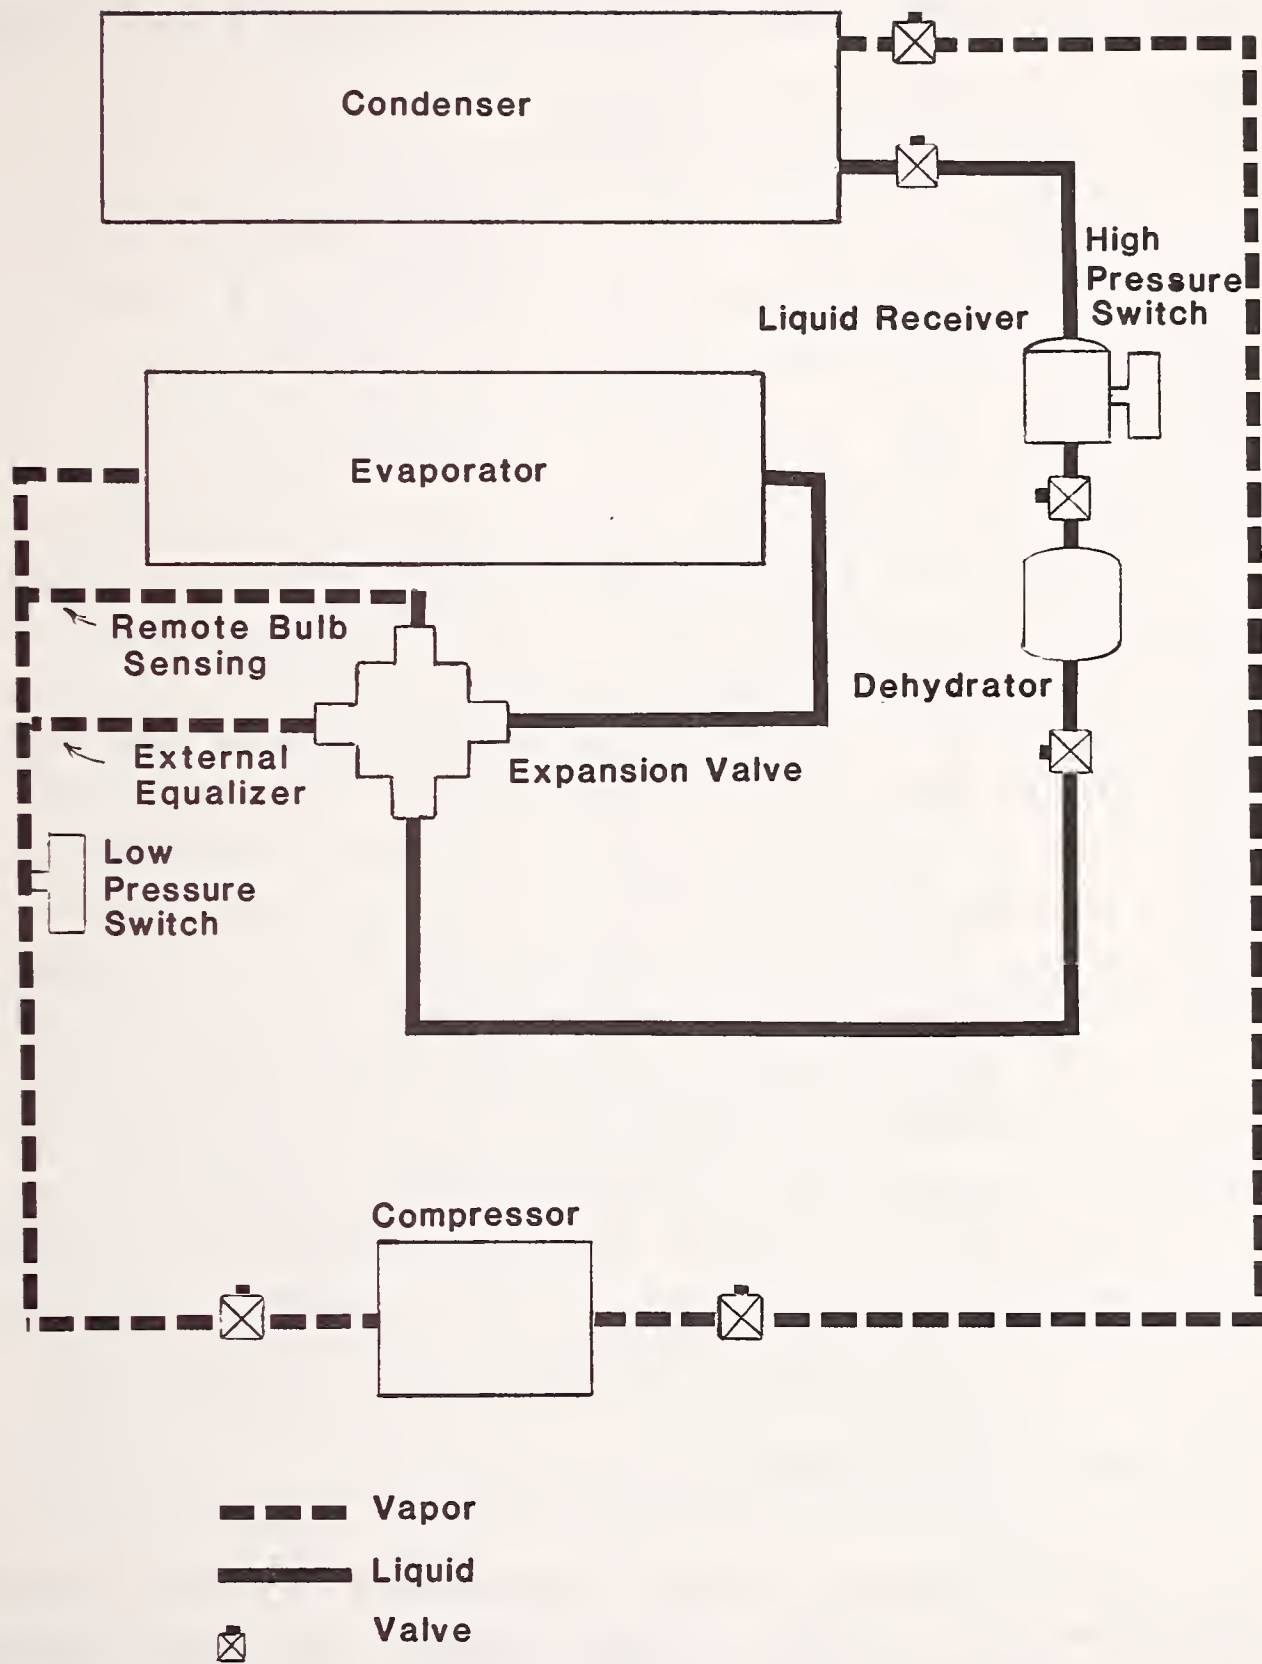
FIGURE 15  
Modified Refrigerant Schematic

Whenever possible, original refrigerant piping was reused, in part or in whole, to minimize the final cost of the modification. A schematic of the resulting refrigerant system is shown in Figure 15.

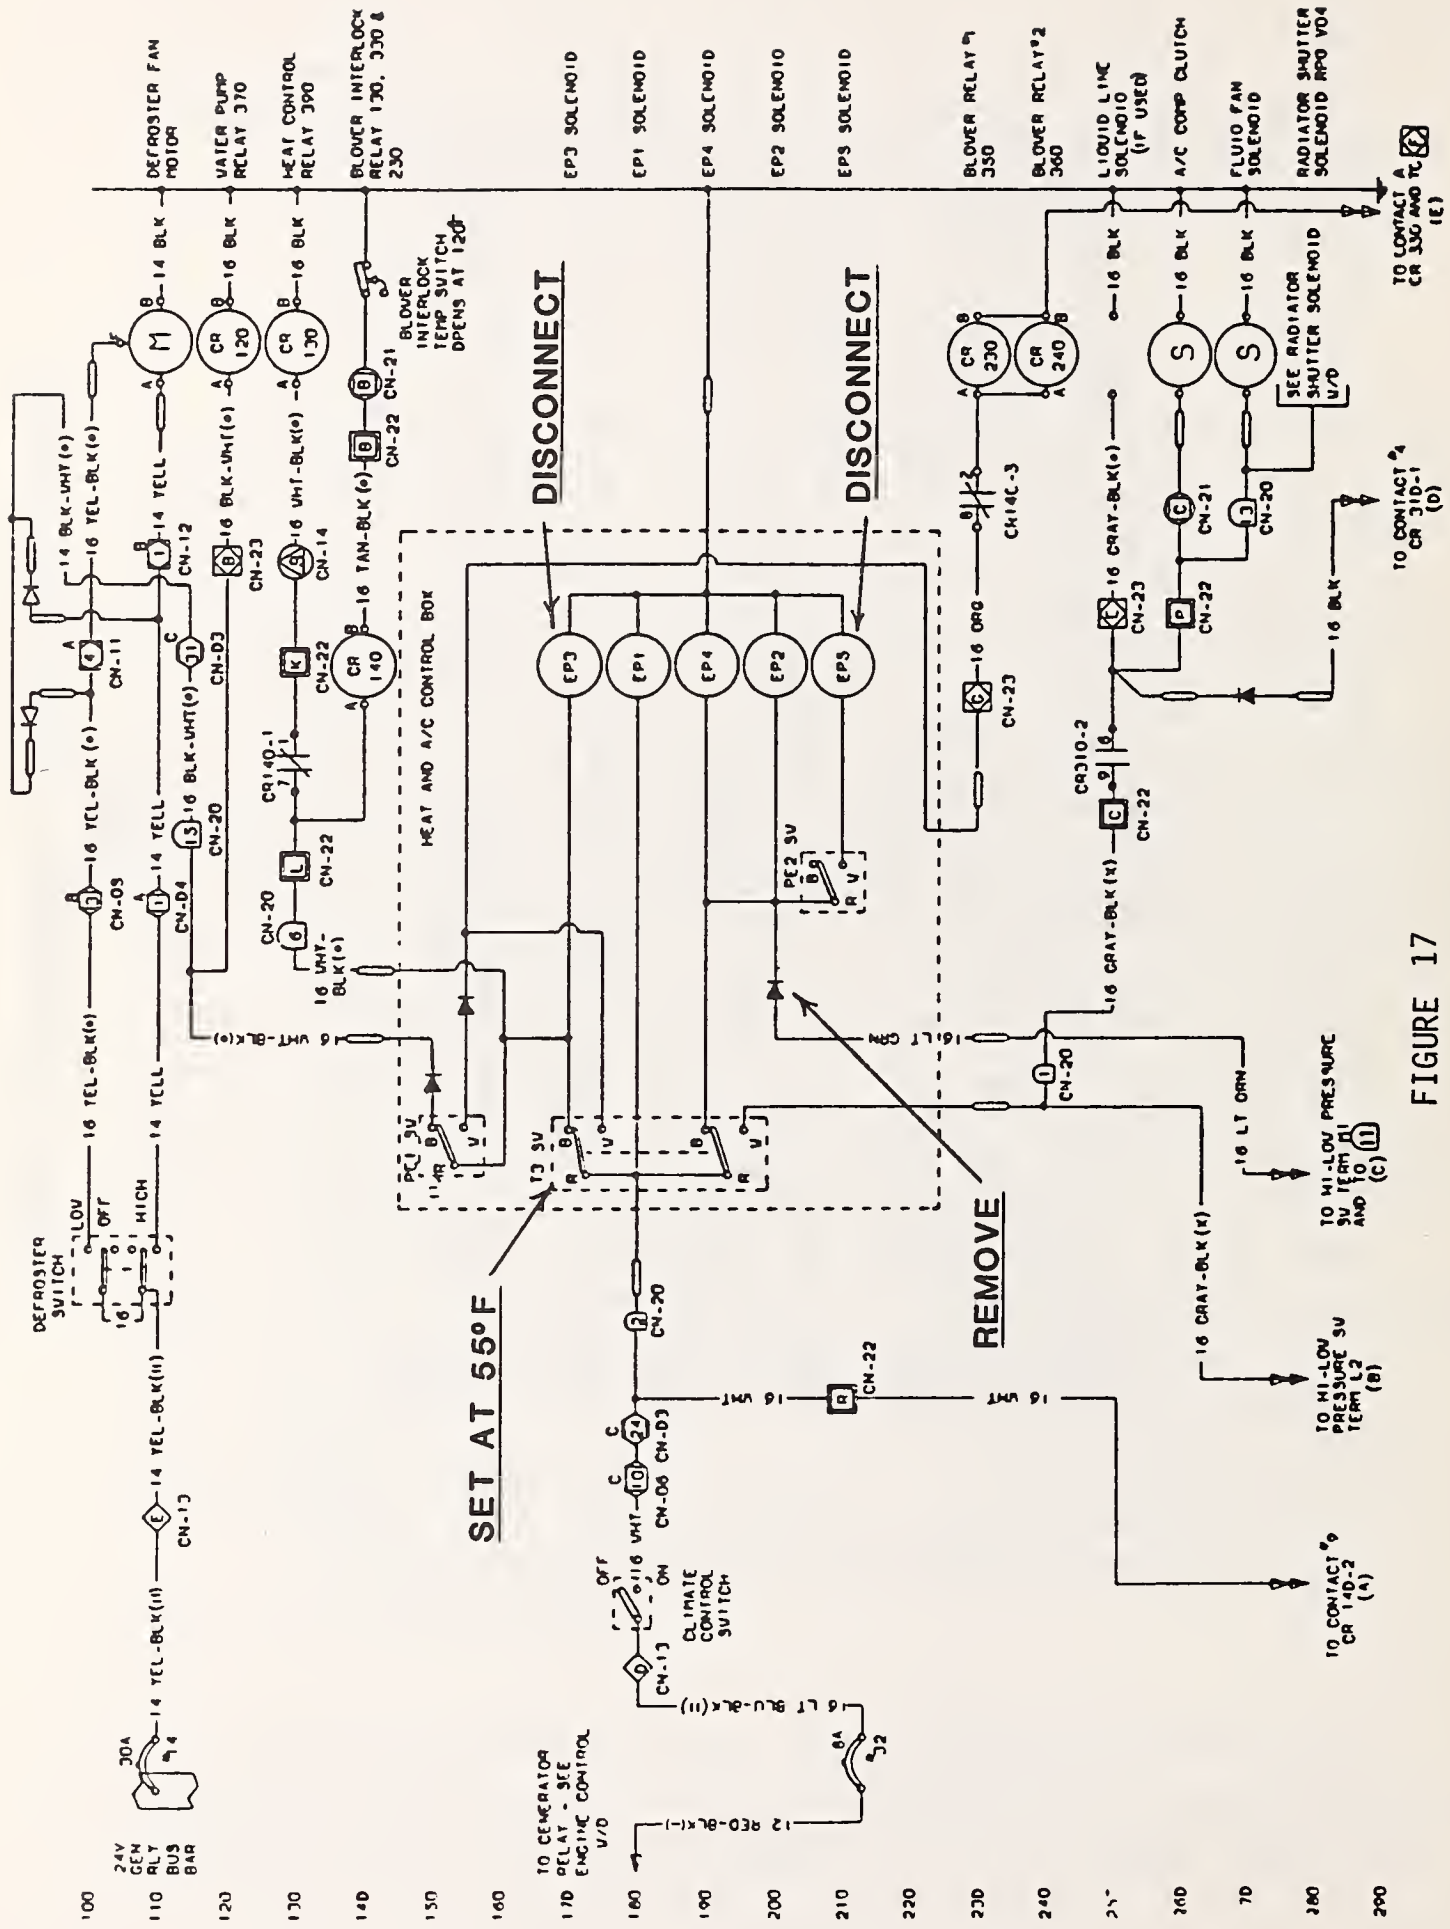
FIGURE 17

The modifications to the Honeywell control are a composite of recommendations from GMC (Field Service letter 78-23) and San Antonio VIA Metropolitan Transit. These modifications are described in Figures 16 and 17. The control box must be relocated in a lower position to allow clearance for the condenser mounting frame and drain pans.

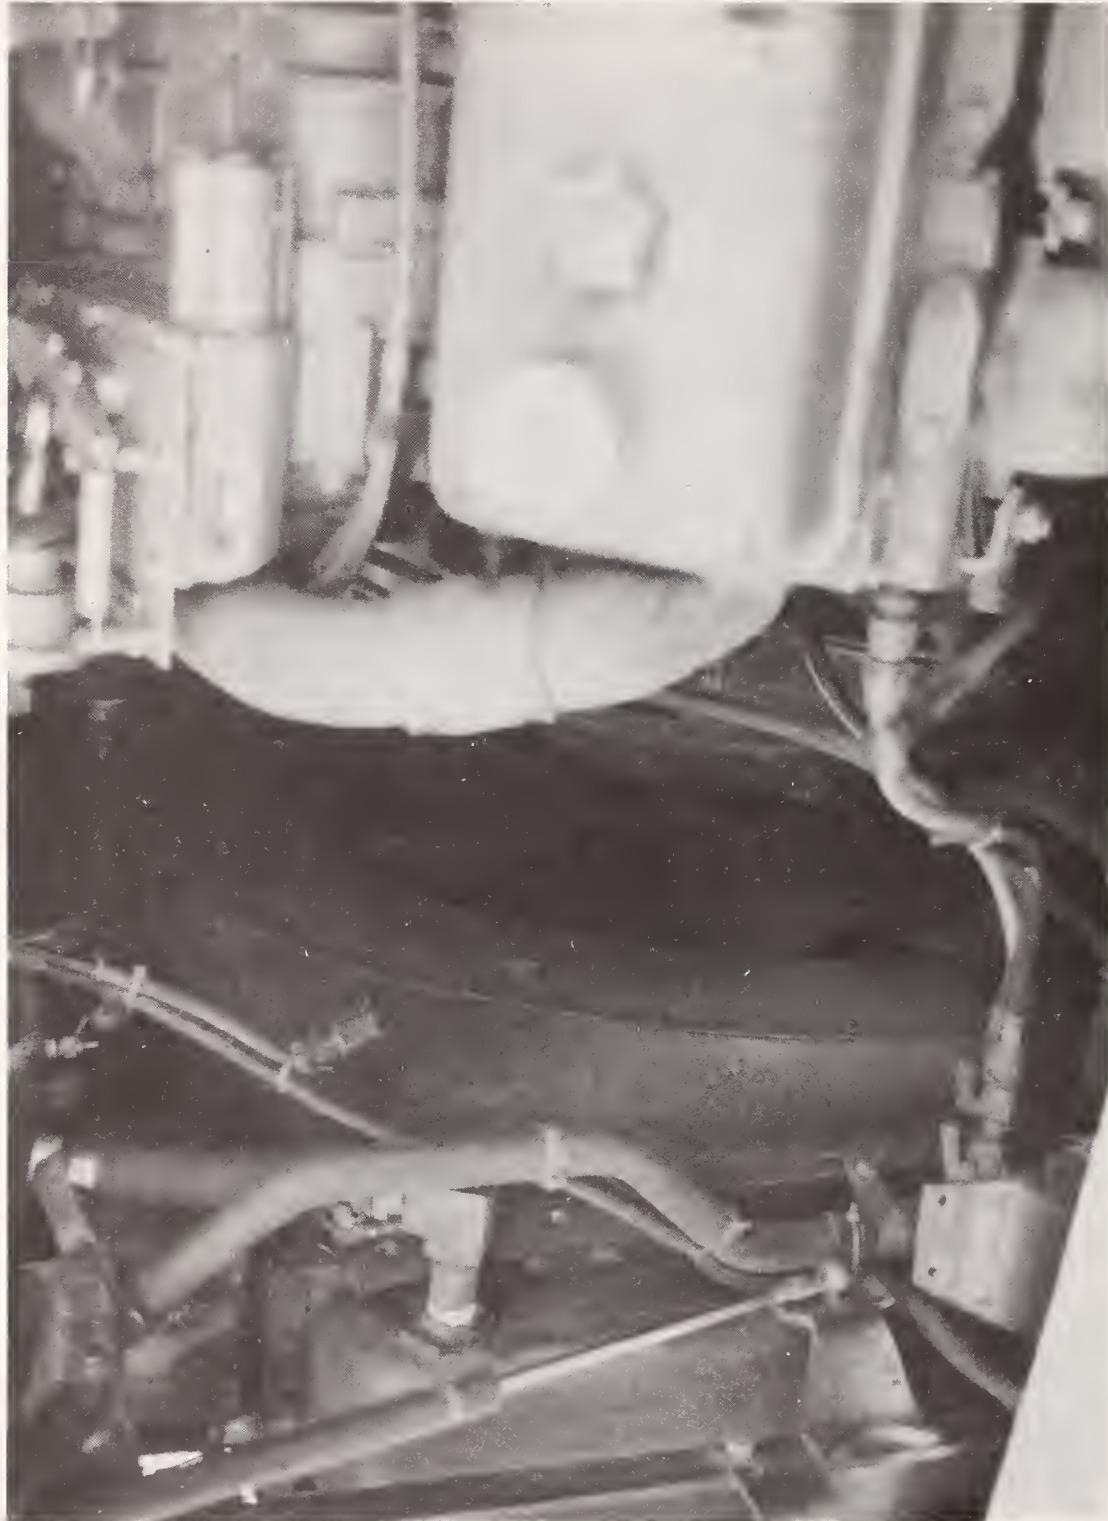
FIGURE 19  
Modified Engine Cooling Fan Shroud

A flat metal ring was attached to the original fan shroud to provide tight clearances with the new fan and thus maximize its efficiency. This is shown in Figure 19.
